Attempting Heroics: Restoring Buccally Angulated Implants

Ryan Leong
University of the Pacific

Ryan Leong D24284

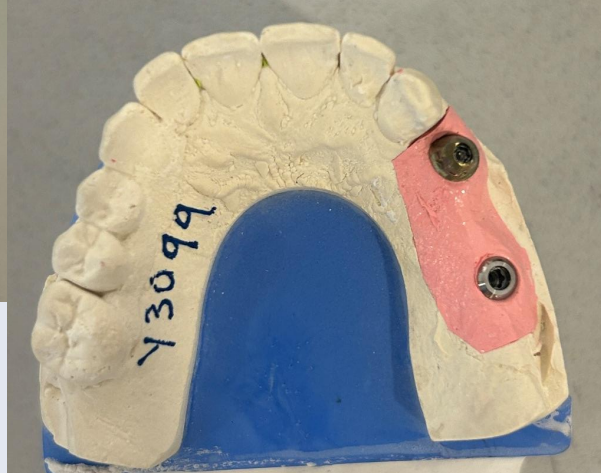
#12 Custom Abutment

Due to placement and angulation of #12 implant, #12 is cement retained¹ and #14 is screw retained.

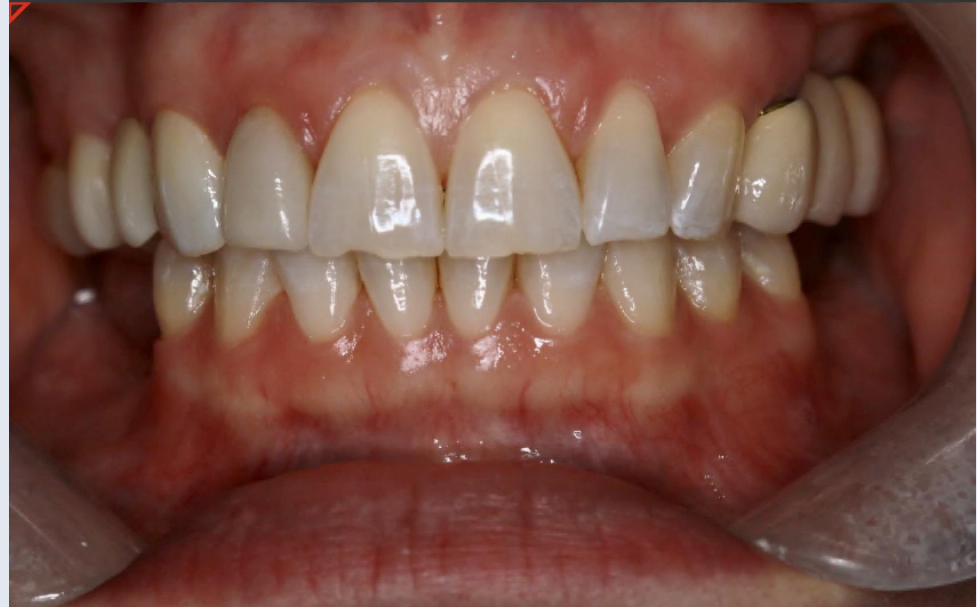
CIMOE Attempt #2 (8/3/23)

Issues:

- Buccal too bulky
- Metal showing at the gingival margin
- Shade too dark
- Path of insertion
- “Looks the same as last time”

Result of the appointment:

- Retake impression with a new verification jig
- Select new shade

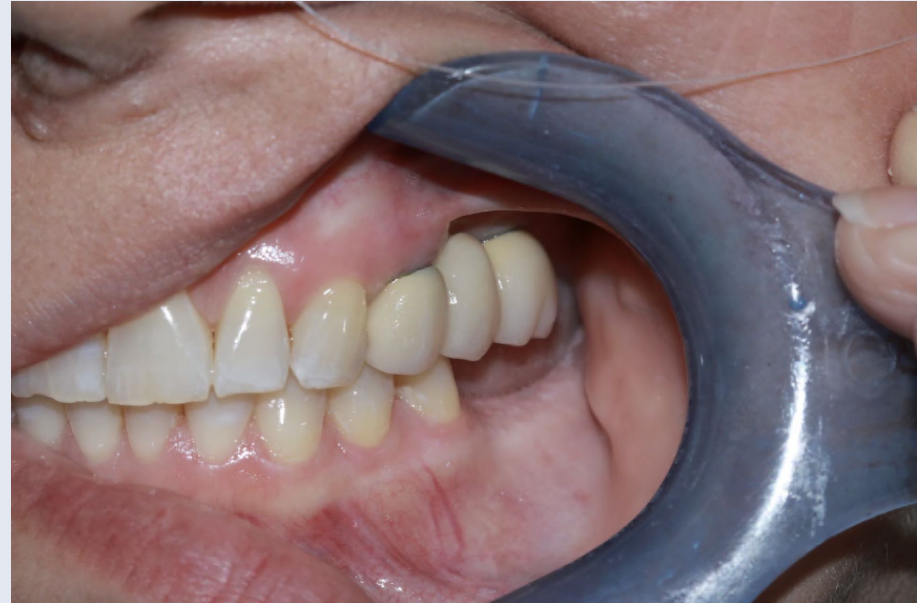
CIMOE Attempt #3 (9/14/23)

Issues:

- Metal margin still showing, but improved
- Shade better, but still too yellow for patient's liking
- Still too bulky on buccal

Result of the appointment:

- Take another impression to recapture soft tissue
- Make shade lighter
- Come up with a new restorative plan

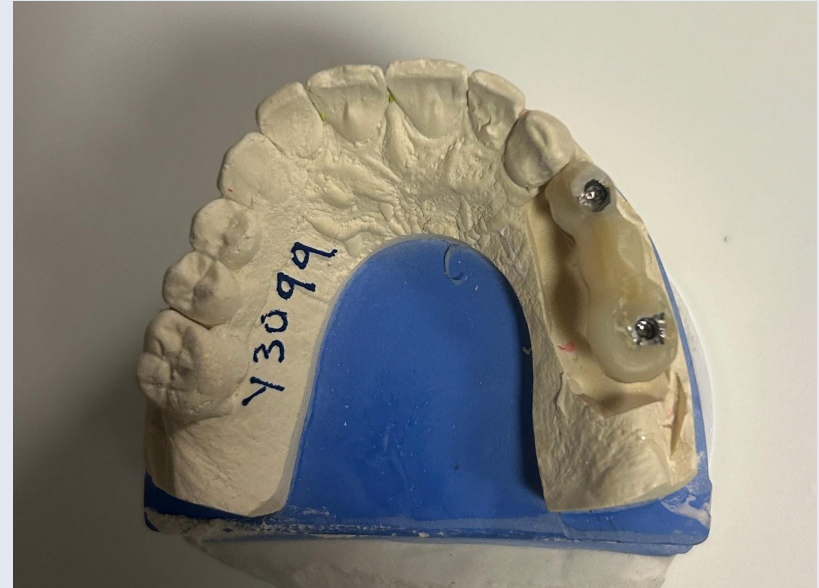
CIMOE Attempt #4 (2/16/24)

Issues:

- Metal Margin still showing
- Still too bulky on buccal
- Shade too light for patient's liking

Result of the appointment:

- Temporary bridge fabricated
- Shade adjusted again

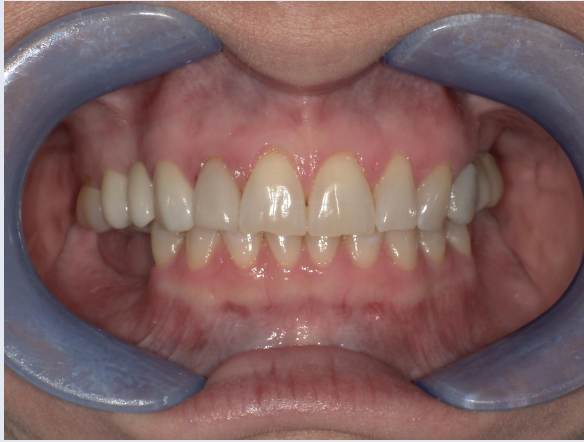
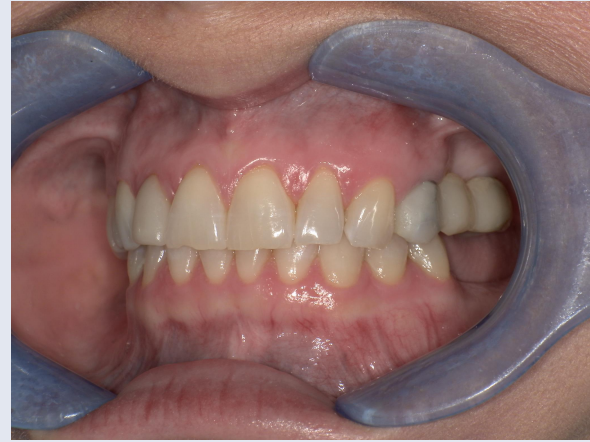
Temporary Bridge

Due to angle of the implant, the temporary abutment showed through the buccal integrity/composite on #12. The metal was reduced as much as possible without perforating into the screw channel.

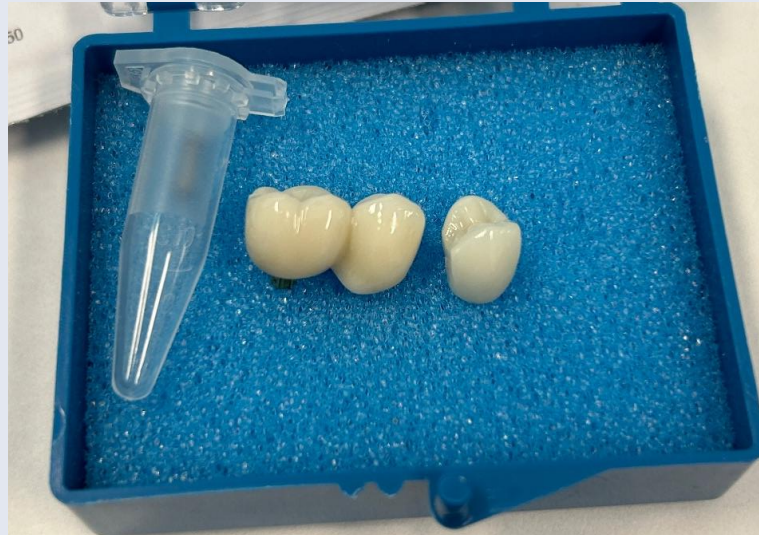
It was suspected that the torquing of #14 was displacing #12, causing incorrect seating.

So we cut #12 off of the bridge, creating a mesial cantilever off of #14, and added porcelain to reestablish contact and to hide margin on #12

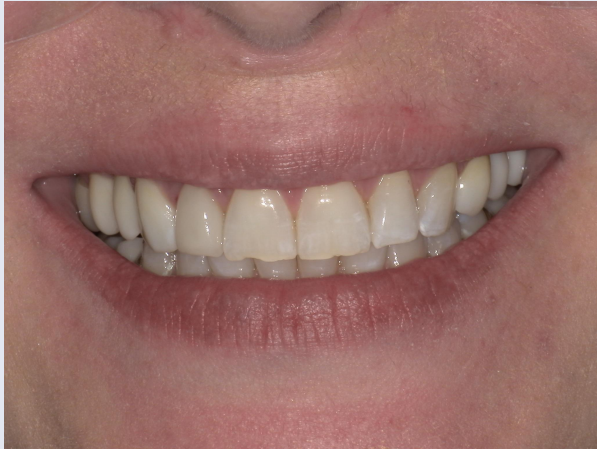
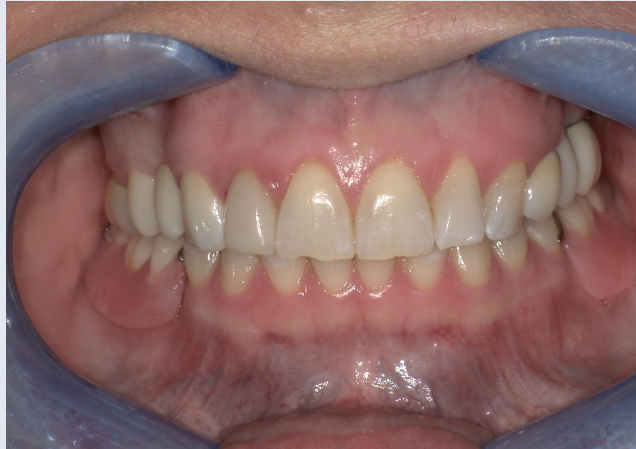
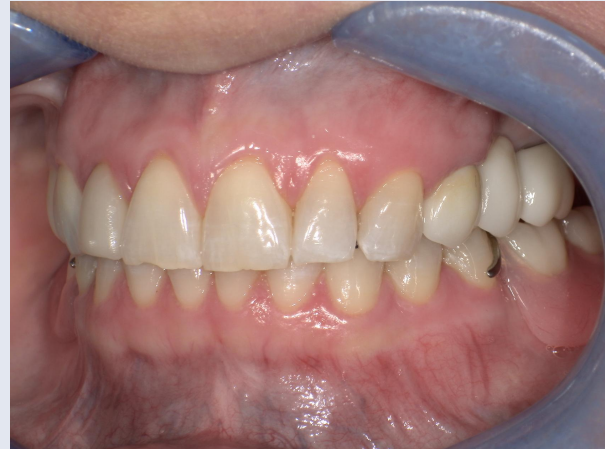
Final Photos

#12 shade blends in very well and patient is very happy with the outcome!
